NASA Technical Paper 1042

Light Airplane Crash Tests at Impact Velocities of 13 and 27 m/sec

Emilio Alfaro-Bou and Victor L. Vaughan, Jr.

NOVEMBER 1977

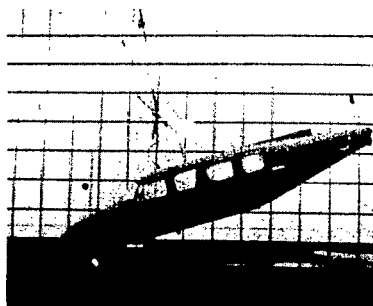
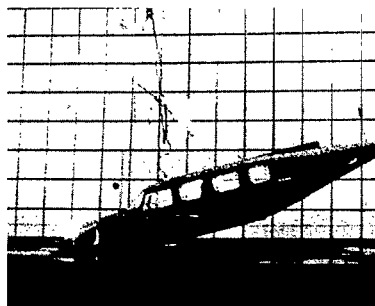
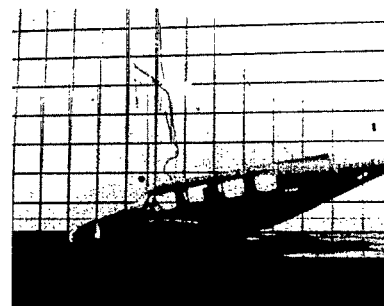
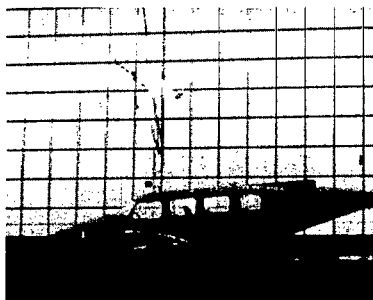
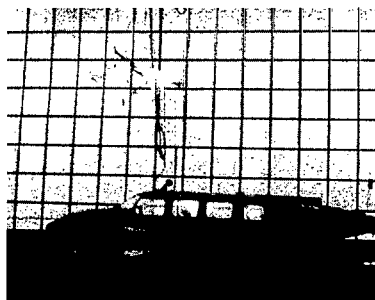
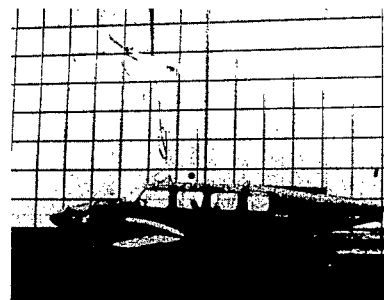
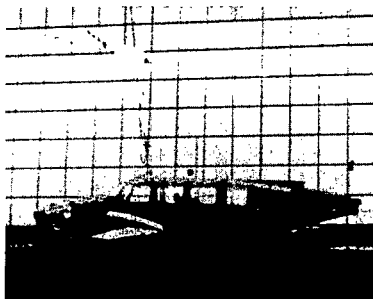
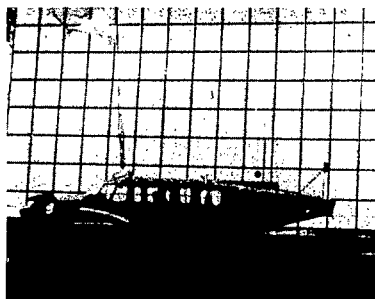
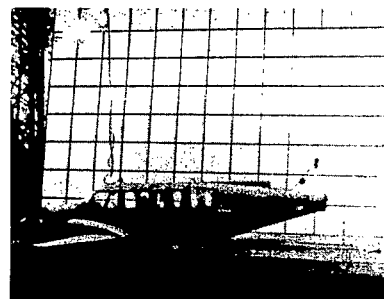
(a) Test 1.

Figures 8(a) and 8(b) are sequences of photographs taken during the first and second test, respectively. Time between frames is 0.05 second. The photographs clearly show the free-flight condition of the test specimen prior to initial impact. The structural damage to the fuselage occurs during two impacts: initial impact followed by a second impact. Initial impact starts when the nose first contacts the landing surface (second frame in test 1 and third frame in test 2). Second impact starts at the time the wing main spar contacts the landing surface (fifth frame). During initial impact, the floor beams in the nose yielded and caused buckling of the nose and fire wall. The combination of downward momentum of the wings and the impact of the main spar with the ground caused twisting of the main spar and loss of wing dihedral angle. For both tests, the structural damage was moderate and the cabin maintained its integrity and liveable volume.

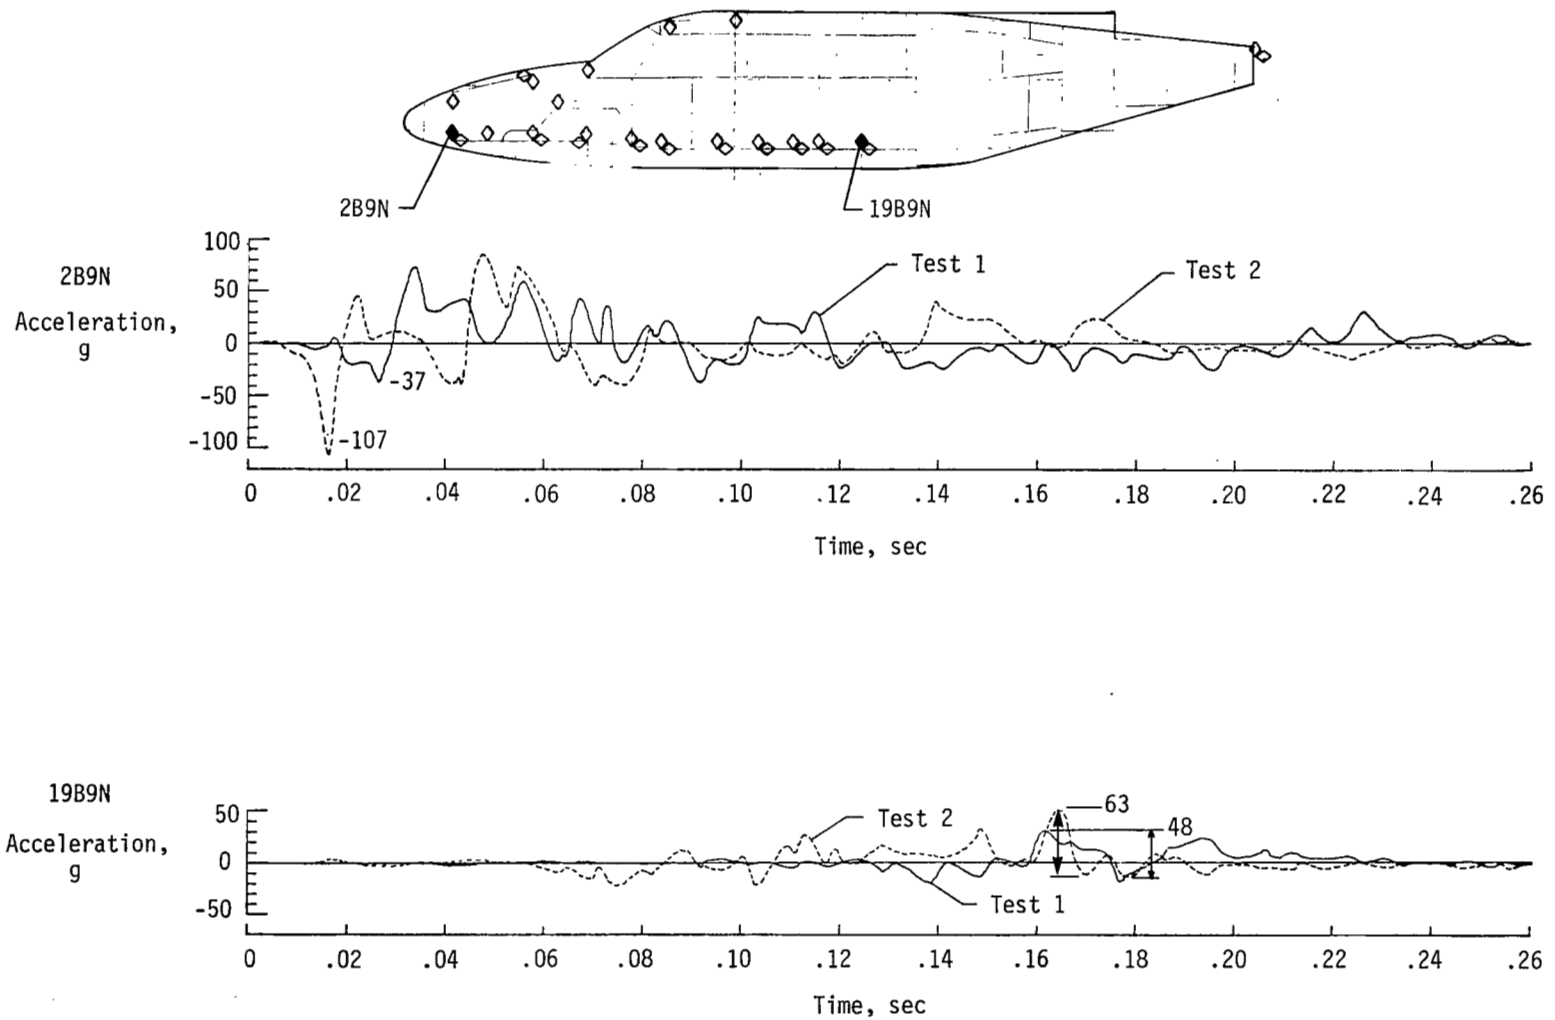
(a) Accelerations at two extreme points.

Acceleration traces in the normal (Z-axis) direction for two extreme points on the floor beam are shown in figure 9(a). The top traces are the acceleration time histories produced by the initial impact in the nose area at point 2B9N. The trace for test 1 (solid line) shows a peak of $-37g$ occurring 26 ms after initial ground contact whereas in test 2 (dashed line) a peak of $-107g$ was recorded 18 ms after contact. The minus signs signify accelerations in the upward direction. ($1g = 9.806 \text{ m/sec}^2$.) After initial impact, the

As the specimen continues to slide forward, the cabin rotates onto the landing surface. The impact in the rear of the cabin was recorded by accelerometer 19B9N located adjacent to the floor beam. A peak-to-peak acceleration of 48g was recorded in test 1 at this location and 63g in test 2. (See fig. 9(a).) Significant accelerations recorded at the rear of the cabin (location 19B9N) do not appear until 125 ms after initial contact in test 1 and after 60 ms in test 2. Acceleration time histories adjacent to the floor beam normal to the longitudinal axis are shown in figures 9(b) and 9(c) for tests 1 and 2, respectively. From top to bottom the traces represent nose to tail accelerometer locations. The higher acceleration peaks of each trace occurred when that location on the floor beam was over the fuselage-ground contact point. Zero time represents initial contact. In test 2 (fig. 9(c)) at twice the impact velocity of test 1, the accelerations were higher and the elapsed time for significant accelerations was of shorter duration.

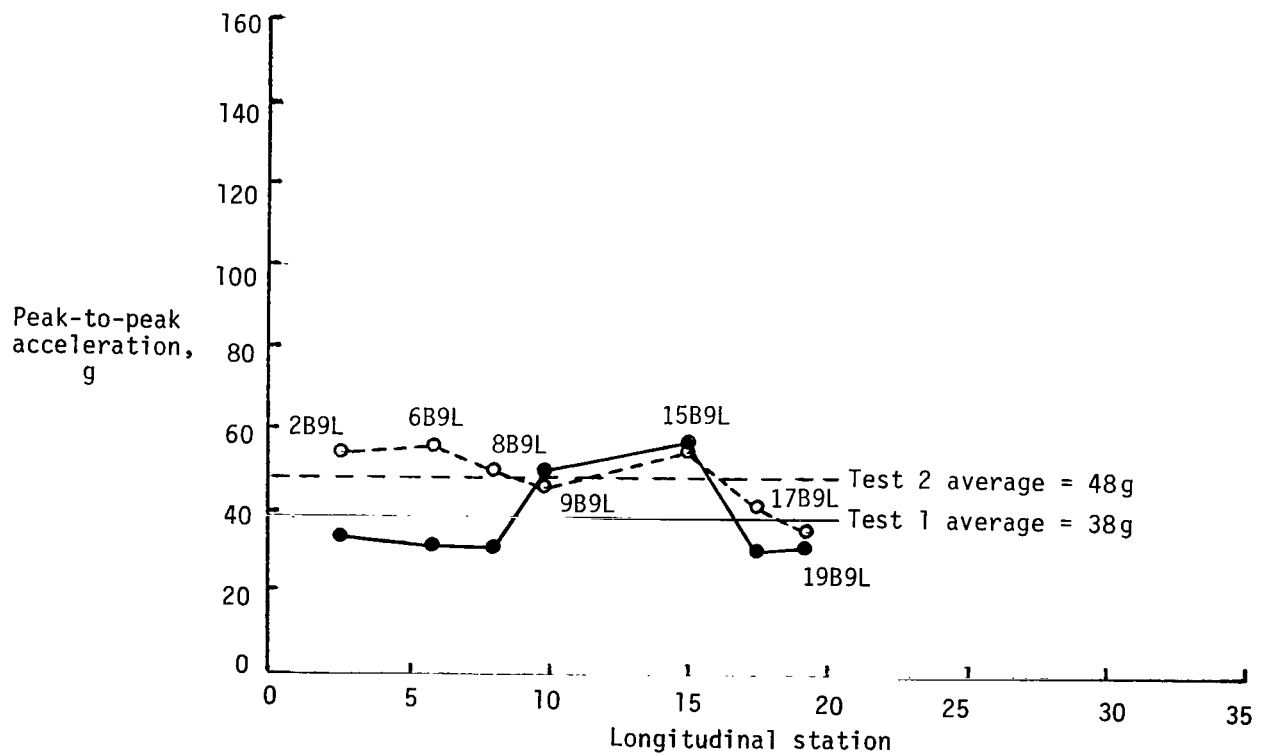
(b) Longitudinal accelerations adjacent to floor beam.

The average values of the longitudinal peak-to-peak accelerations at locations adjacent to the floor beam are shown in figure 12(b) and were approximately 40 percent lower than the normal acceleration value in corresponding locations for test 1 and 57 percent lower for test 2. In test 1 the peak-to-peak longitudinal values were higher near the main spar and correspond to high normal acceleration values at the same location. In test 2, the average value of longitudinal peak-to-peak accelerations was 26 percent higher than in test 1.

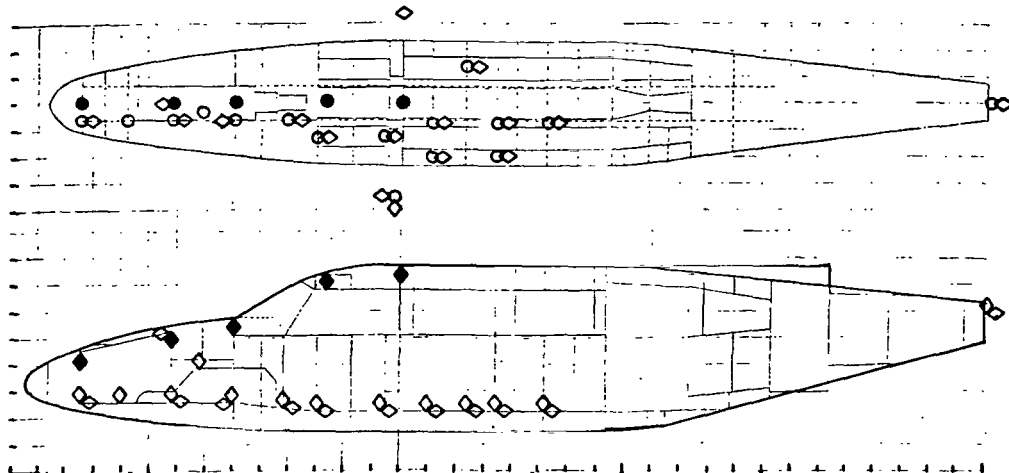
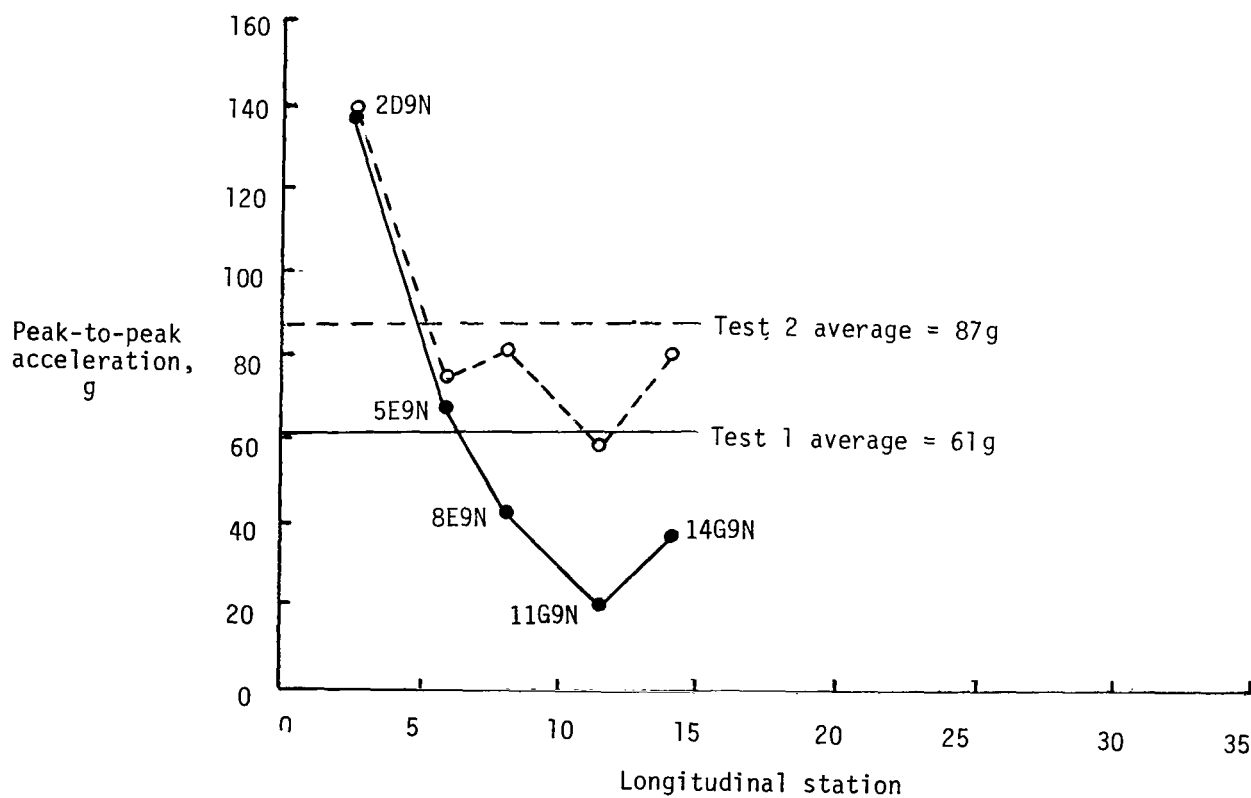
(c) Normal accelerations on roof.

The peak-to-peak accelerations normal to the roof were higher in the nose area. Average values were 43 percent higher in test 2 than in test 1 and are shown in figure 12(c). Figures 12(d) and 12(e) show the peak-to-peak accelerations on the cabin floor in the normal and longitudinal directions, respectively. In test 2 both the normal and longitudinal peak-to-peak accelerations were approximately 52 percent higher than in test 1.

The peak-to-peak normal accelerations on the roof (location 14G9N, fig. 12(c)) and adjacent to the floor beam (location 15B9N, fig. 12(a)) are 36g and 85g, respectively, for test 1 and 80g and 150g for test 2. In this comparison, the roof accelerations are 58 percent lower than those at the floor beam for test 1 and 47 percent lower for test 2. The lower roof accelerations reflect the effect of fuselage shell deformations and load alleviation as discussed for figure 11. After the impact was over, the cabin structure returned approximately to its original shape, but the floor beams remained deformed. In this test the apparent floor beam protrusion resulted in a slight rotation of the seats toward their respective side windows as shown in figure 11(d).

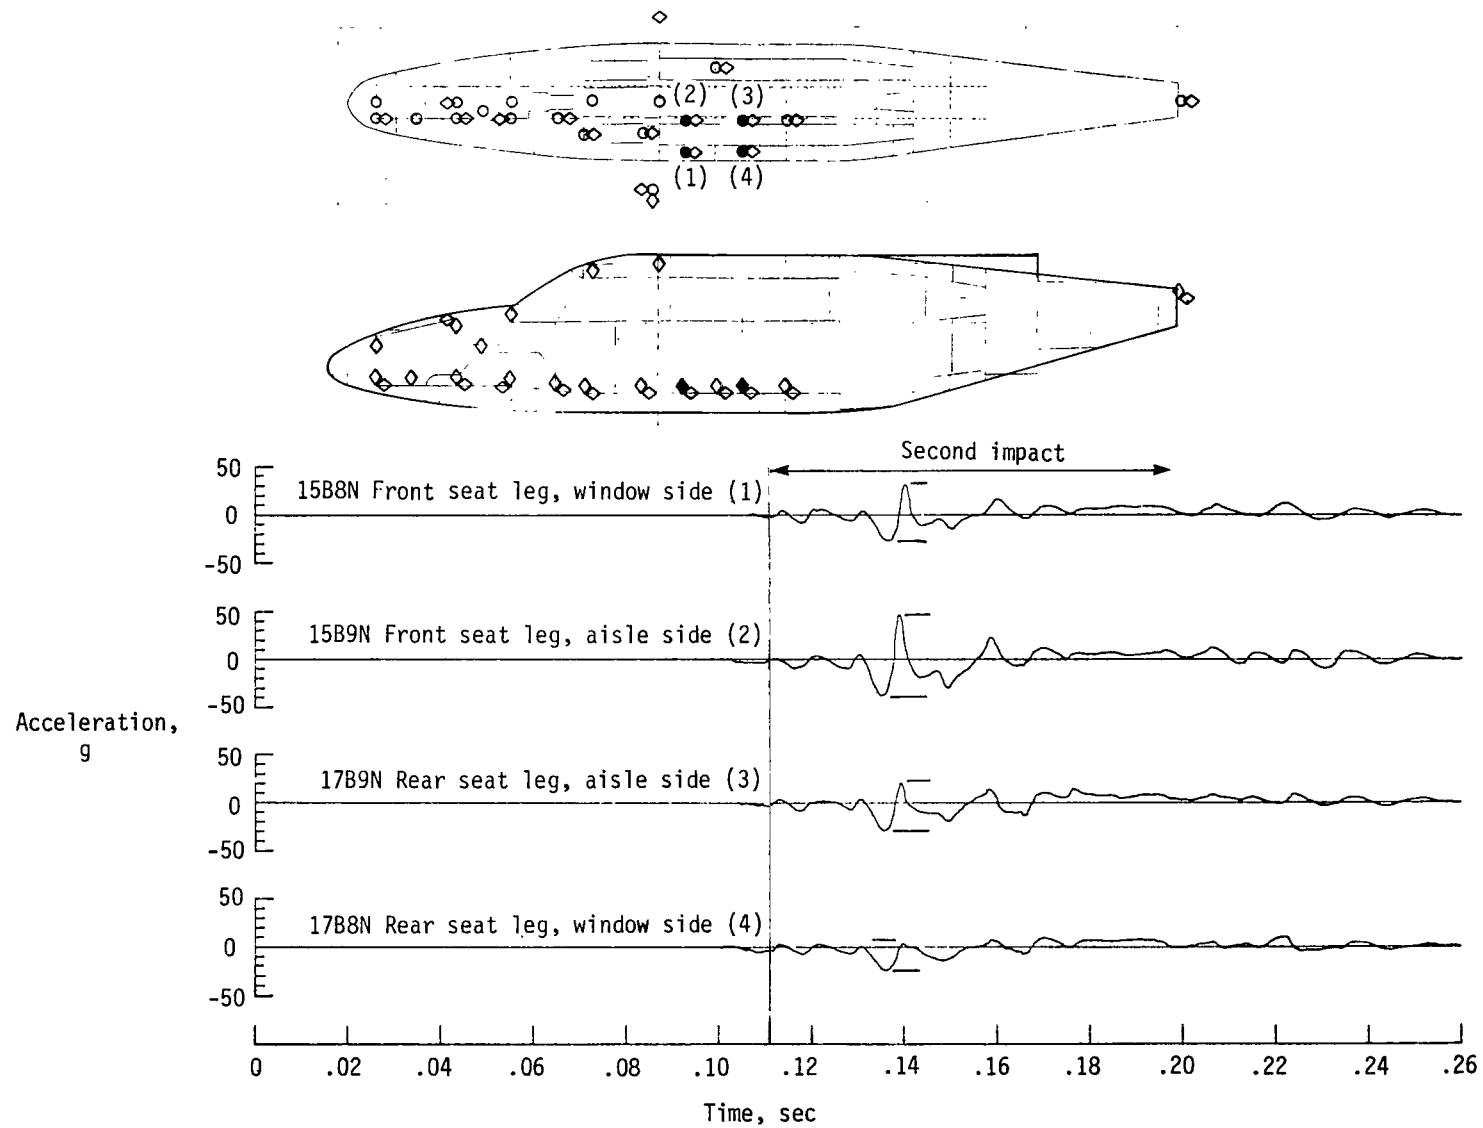
(a) Test 1.

Figure 13 is a plot of the normal accelerations on the floor at the base of the first passenger seat. The time of main spar contact with the ground was determined photographically and is superimposed on the traces for reference. In test 1 (fig. 13(a)) and in test 2 (fig. 13(b)) the combined effect of structural deformation, angular acceleration, and timing produces higher peak-to-peak accelerations on the cabin floor at the front seat legs compared with the accelerations at the rear seat legs. Also during second impact the peak-to-peak accelerations on the floor were higher on the aisle side than those on the

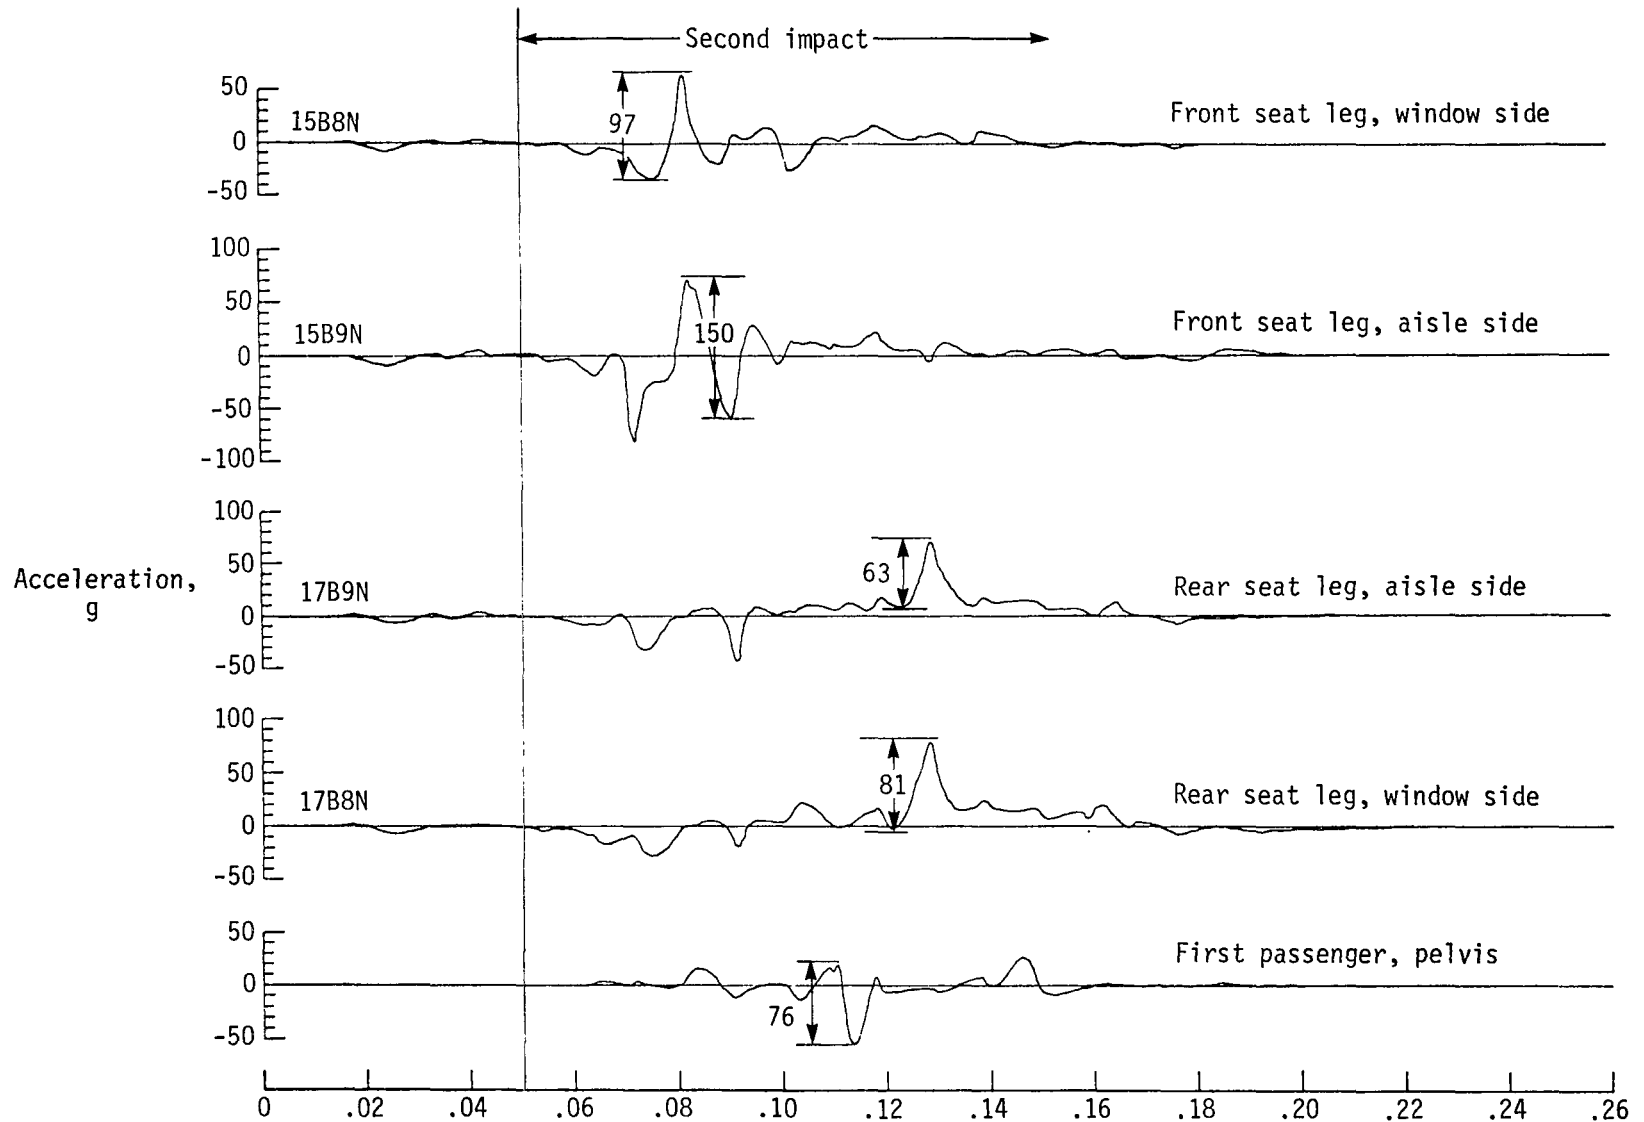
(b) Normal accelerations on floor and dummy pelvis along spine. Test 2.

In test 2, the peak-to-peak acceleration at the dummy pelvis along the spine was 76g (fig. 13(b)). In test 1 the dummy pelvis was not instrumented. Although a direct comparison between normal peak-to-peak accelerations on the floor and on the dummy pelvis could not be made because the orientation of the accelerometer along the spine changed with dummy motions during the test, it appears that some energy dissipation or force alleviation has taken place due to seat deformation. The front seat legs are experiencing peak-to-peak normal accelerations of 97g and 105g. (The rear seat legs are averaging closer to normal peak-to-peak accelerations of 72g.)
